The Kitchen

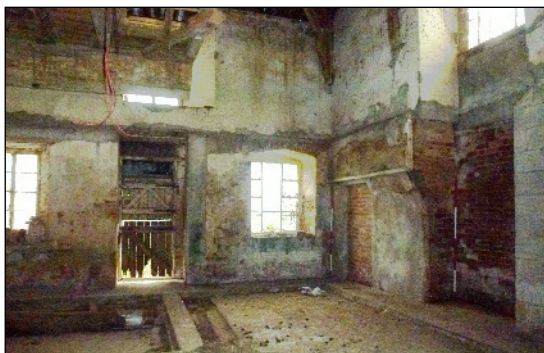
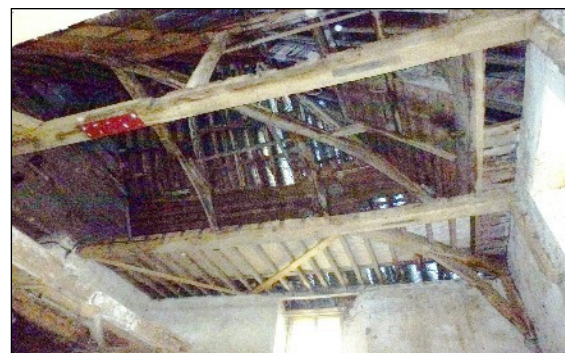
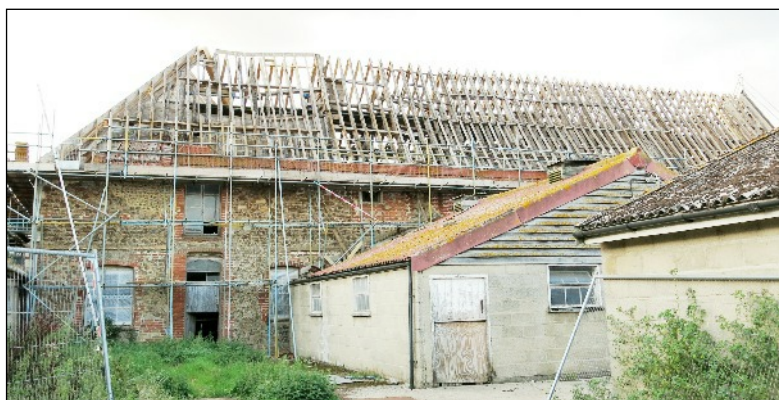
*(left): Kitchen doorway with 16th century window opening and fireplace;
(right) Kitchen ceiling beams with boarded loft above; (below) south elevation during restoration of the roof. The door will have opened into a kitchen yard.*

The Chronicle of Butley Priory records the modernization of the Kitchen in 1518 when three hearths, two ovens and coppers were installed in a single room which received a new roof – all at the expense of the prior. In previous years he had spent 100 marks of his own money on repairs. Of typical medieval kitchen proportions, it was about 23 feet square, smaller than those found in major
