## The tradition

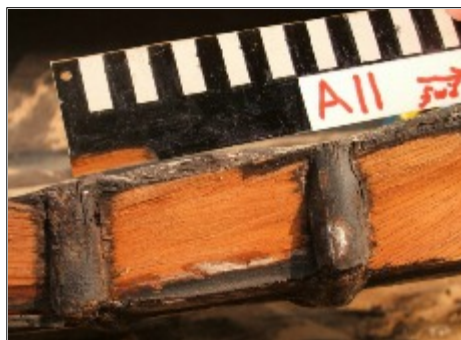
Figure 21. Fracture shows encrusted surfaces and wedges in stitch-holes impregnated with *dikh*. Benaulim. Author.

The wedges served to make each stitch mechanically independent of its neighbour; thus localised damage did not loosen adjacent stitches, much less did it affect a *dikh*-impregnated seam.

With the exception of the thwart-beams and sacrificial members, the new boat inside and out was carefully treated and every three-months thereafter, resulting in a build-up (Fig. 21).
